Initial Seismic Vulnerability Assessment of Jigme Dorji Wangchuck National Referral Hospital Thimphu, Bhutan

July 31, 2012

Prepared for the World Health Organization Regional Office for South-East Asia by

GEOHAZARDS

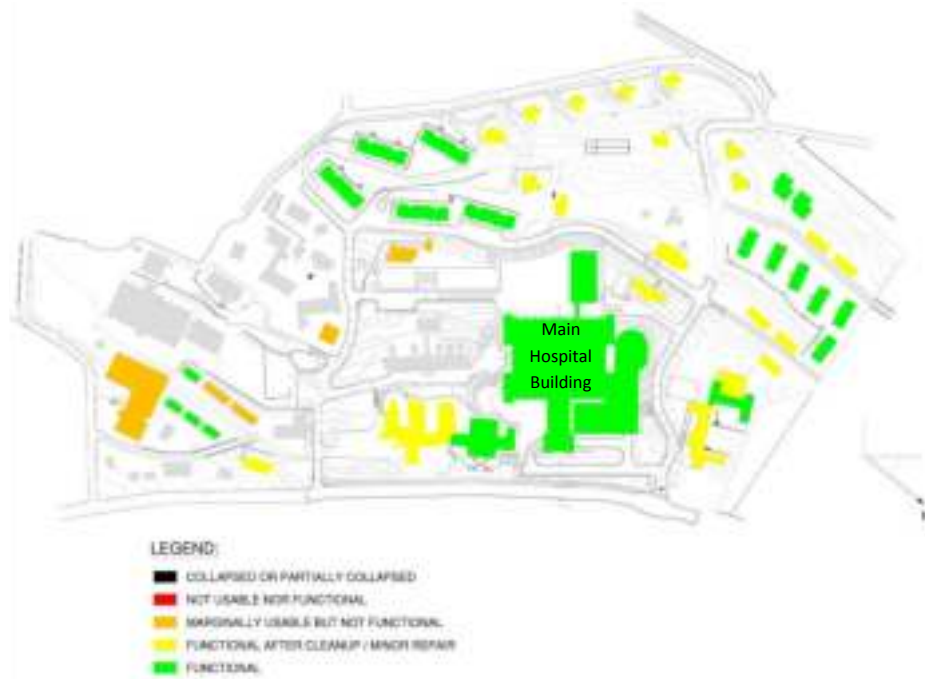
Site plan showing likely performance of hospital buildings in M6.1 hypothetical scenario earthquake

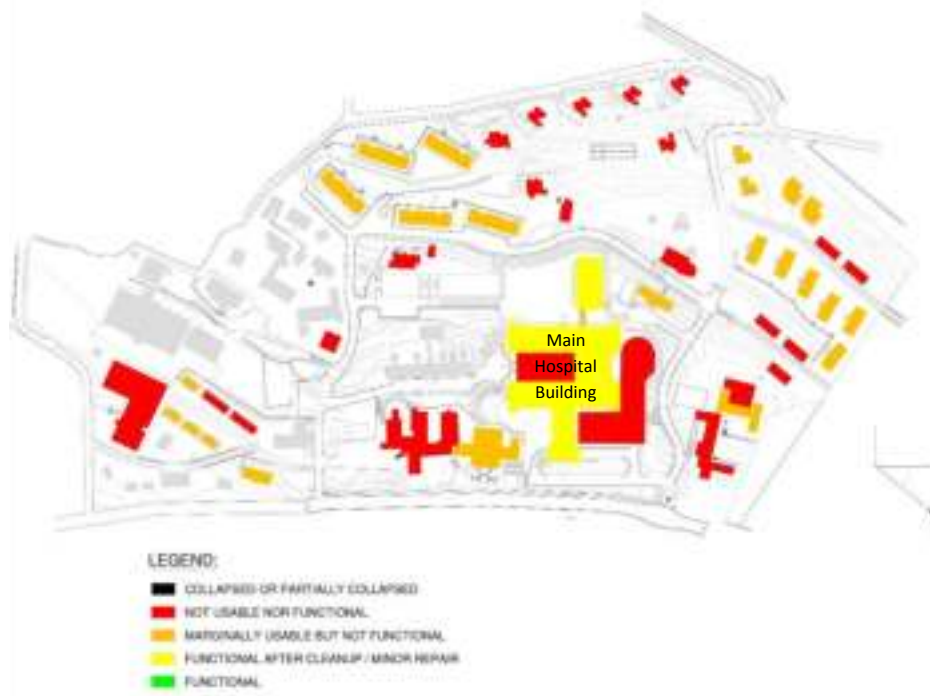
Site plan showing likely performance of hospital buildings in M7 hypothetical scenario earthquake

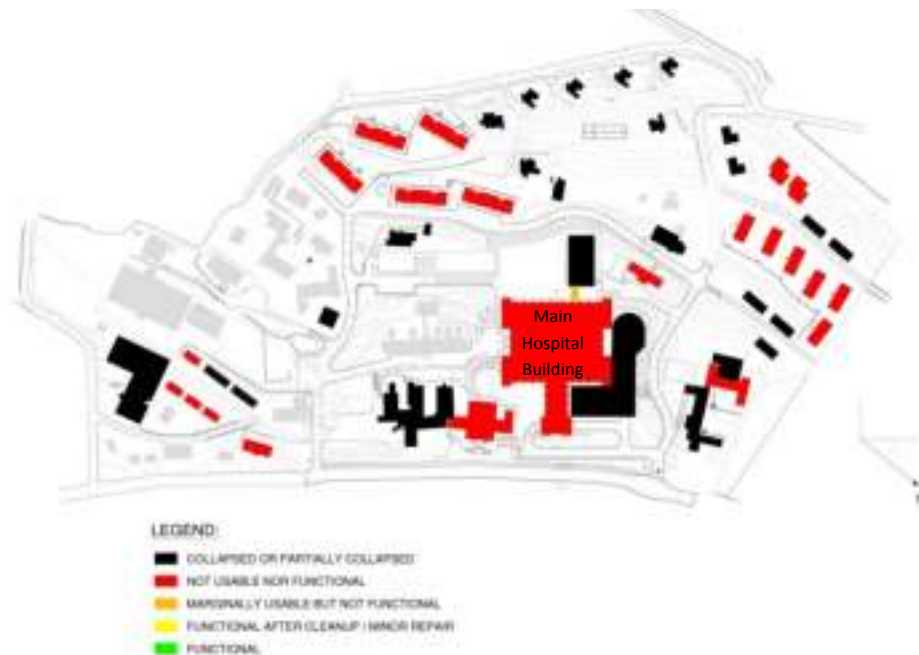
Site plan showing likely performance of hospital buildings in M8.6 hypothetical scenario earthquake

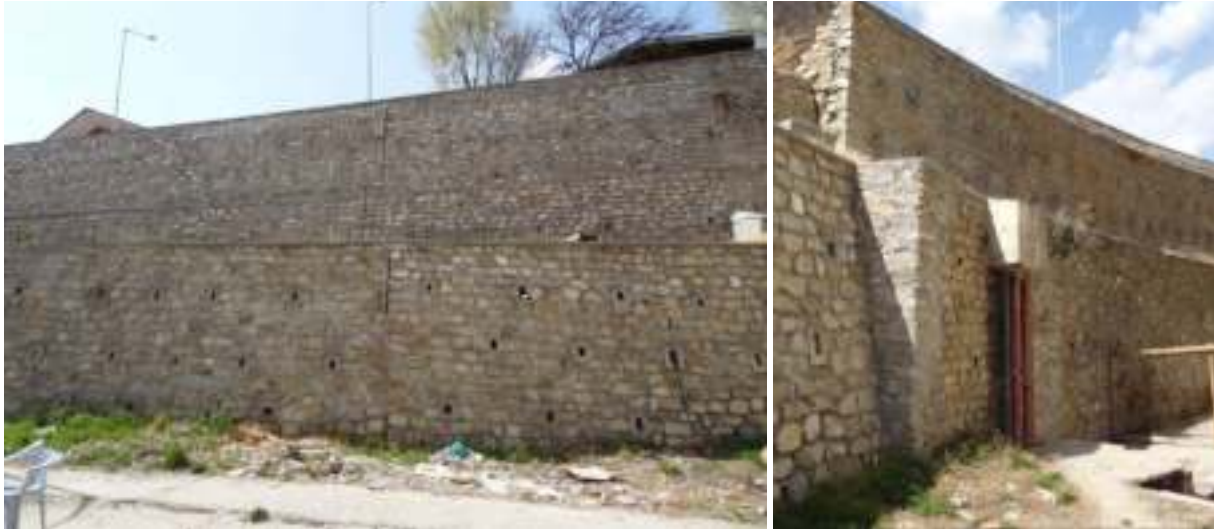
rear of the main hospital building. The large retaining walls, some of which are shown in Figure 4, must be evaluated, because instability would threaten the hospital's ability to function. These walls may be unreinforced stone masonry and if so, could be highly vulnerable to earthquake damage.

Figure 4. Retaining wall behind the Service Block (left); pipes emerging from the same retaining wall (right)

The evaluation team understands that no portion of the hospital was built on fill. If portions of any building have been built on fill, then those fills could be susceptible to differential settlement during an earthquake, possibly causing additional damage to that which is described in this report. The evaluation team did not investigate the adequacy of drainage and stormwater management at the site, but these should be assessed. The site does not contain creeks or streams, though there may be a small stream on the south side of the Royal Institute of Health Sciences. The team recommends that any detailed evaluation include a thorough investigation of the site's geotechnical conditions, including any fills if present, as well as drainage conditions and the major retaining walls.

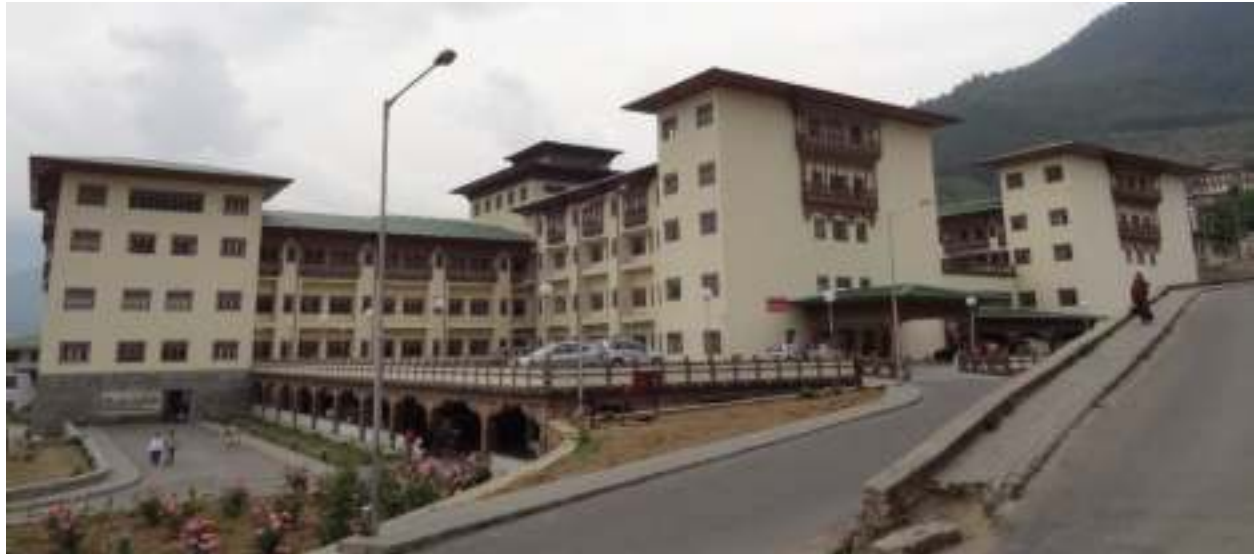
Figure 5. Exterior view of new Main Hospital Building showing parking garage (lower foreground), main entry (left) and ambulance entry for emergency department (right). Note captive columns (see page 20) caused by partial height masonry walls and decorative Zhu in parking garage.

The parking structure has what structural engineers call *captive columns* or short columns, where stiff partial height masonry walls and the decorative *Zhu* at the tops of columns impede the columns' ability to move back and forth during an earthquake. Numerous past earthquakes have shown that buildings with captive columns are prone to major damage and collapse. These columns are likely to suffer heavy damage in the M7 and M8.6 hypothetical scenario earthquakes. Local collapse of these columns in the outer bay of the parking structure is possible in the M8.6 hypothetical scenario earthquake.

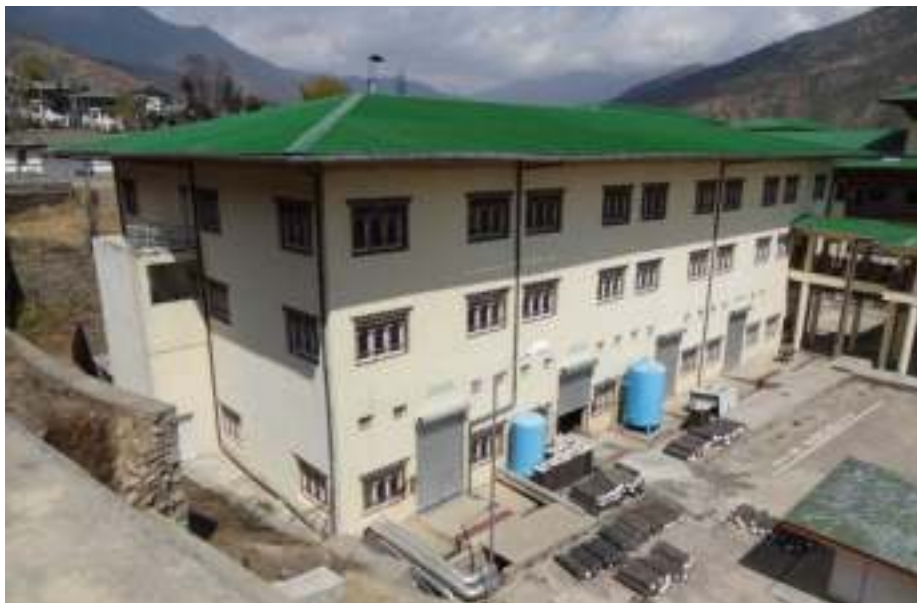
Figure 8. Exterior view of Service Block taken from top of retaining wall behind hospital, showing tanks for vacuum (blue) and empty medical gas cylinders awaiting pickup. Bridge to main hospital is at right.

The taller ground storey with relatively fewer columns, which is necessary to accommodate large mechanical equipment, makes the building seismically vulnerable. This storey is more flexible than the storeys above it are, and earthquake-imposed deformations and damage will tend to concentrate in this storey. Table 3 shows the likely performance of the Service Block in three hypothetical scenario earthquakes, which illustrate a range of damaging earthquakes the hospital might experience.

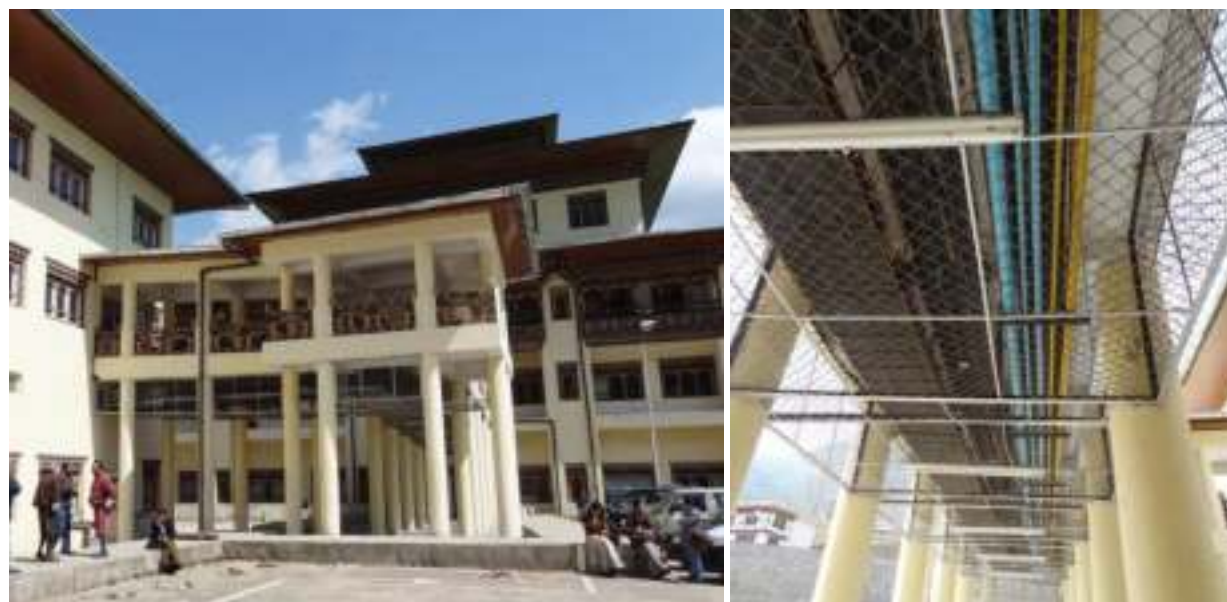
Figure 9. Bridge connecting Service Block to main hospital building (left); conduits and pipes suspended from walkway (right)

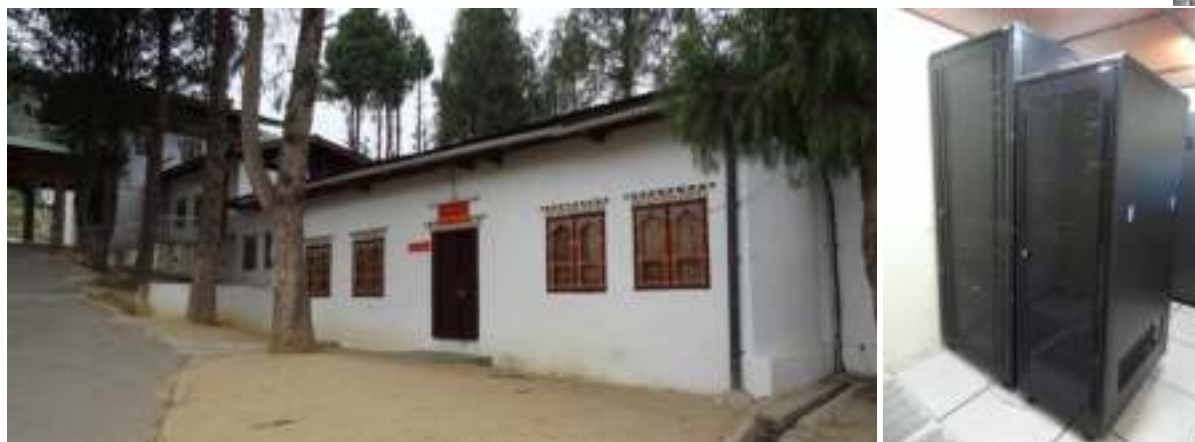
Figure 17. Health Help Center building (left); unanchored servers for the 112 emergency system (right)

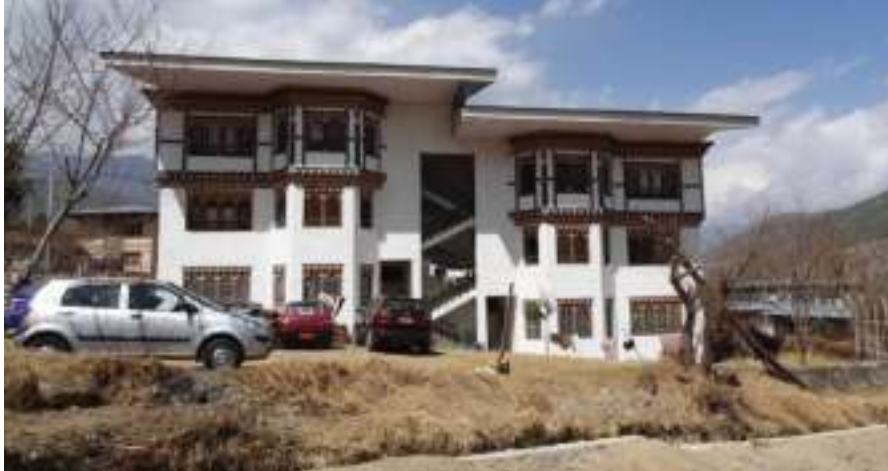
Figure 27. Nurses' quarters (Type 2) with 6 units and a large vertical discontinuity in the center of the building

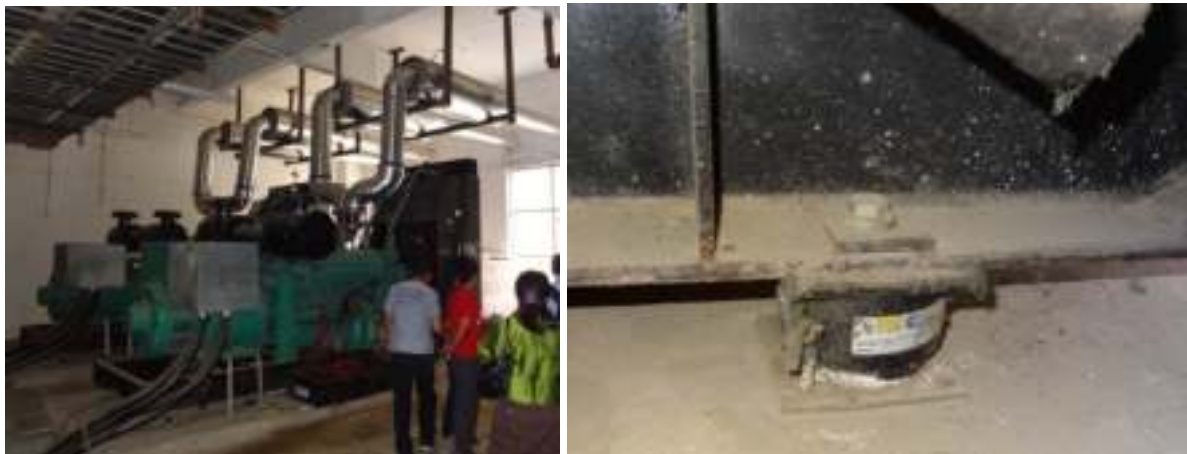
Figure 33. Unanchored emergency generator with inadequately braced exhaust system and unsecured batteries (left); non-seismic vibration isolators (right)

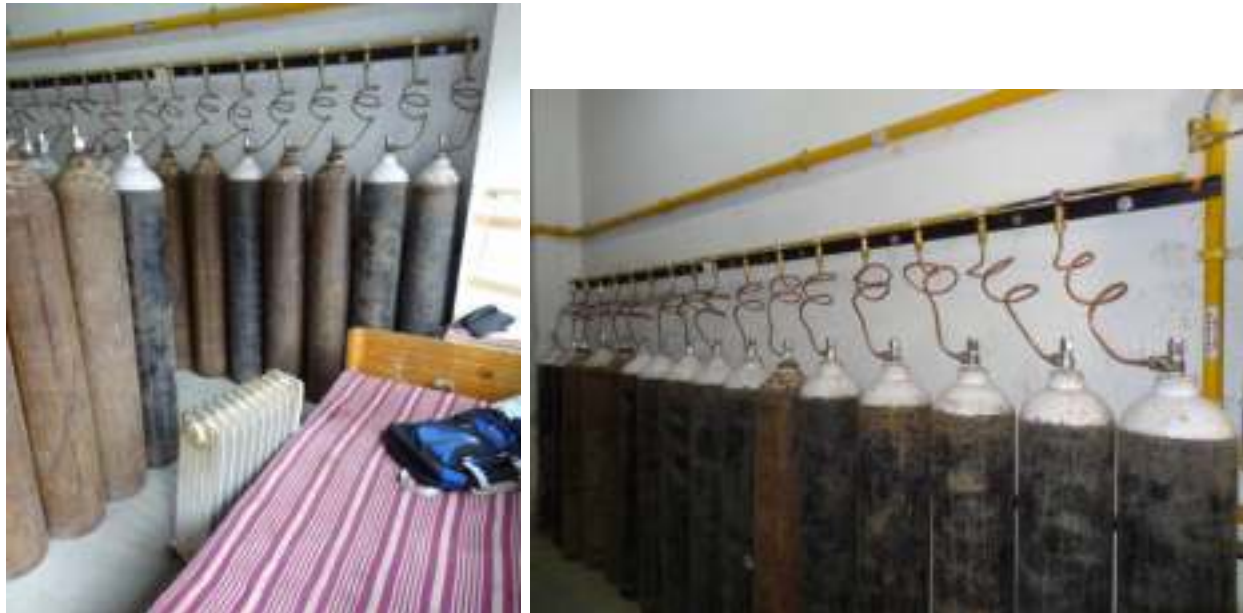
Figure 34. Unsecured medical gas cylinders; note the space heater

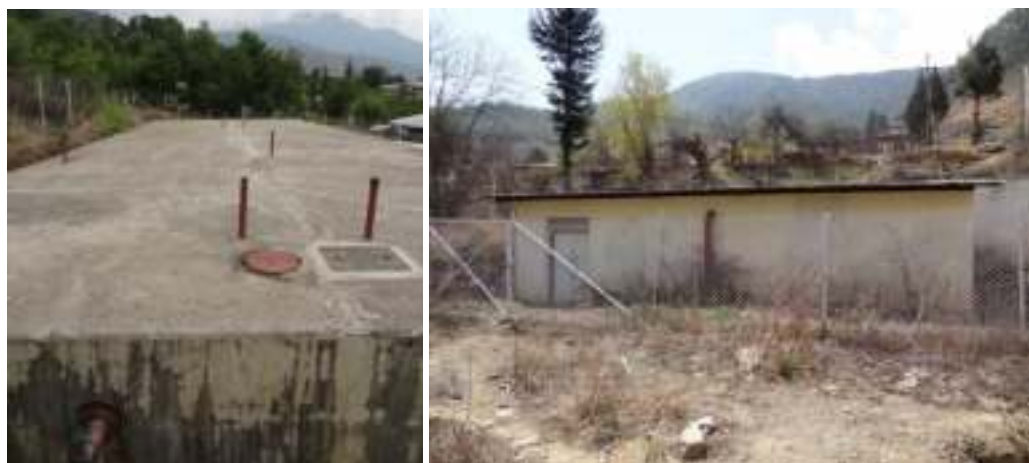
Figure 35. Drinking and fire suppression water storage tank (left); unreinforced masonry pump house below tank (right)

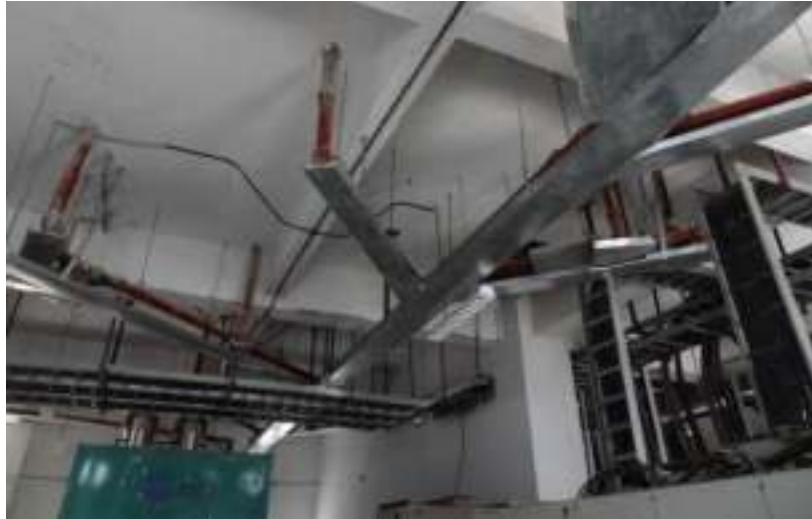
Figure 36. Suspended, unbraced wastewater pipes above a generator and electrical equipment in the Service Block

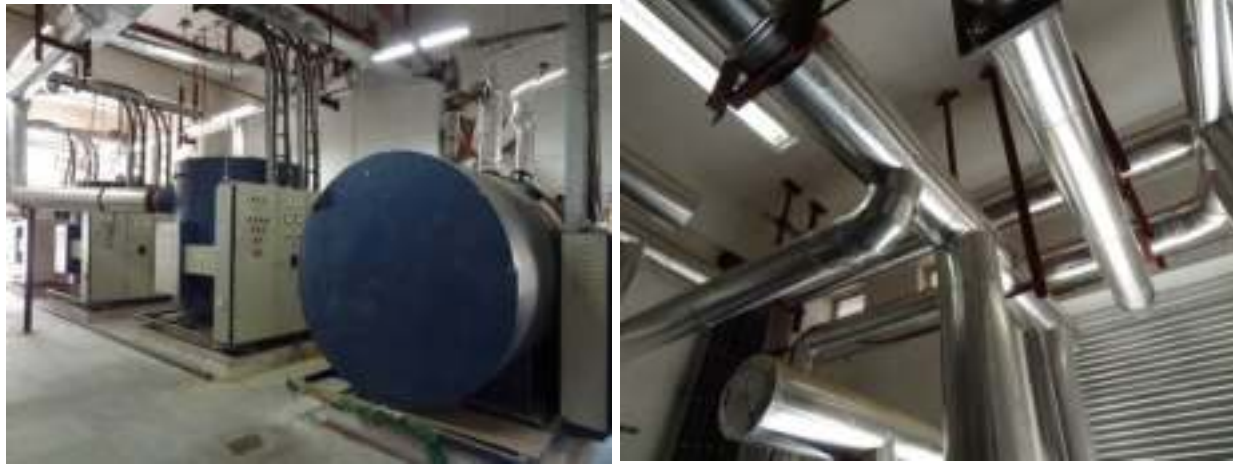
Figure 37. Unanchored boilers (left) and laterally unbraced pipes (right) in the Service Block

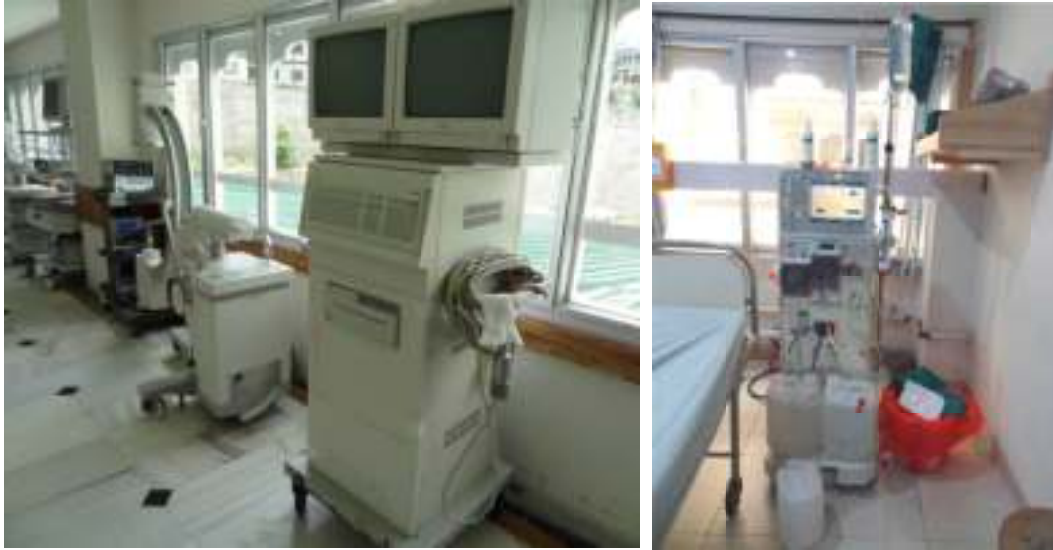
Figure 38. Mobile equipment used in OTs stored without tethers in hallway (left); tall, narrow dialysis equipment (right)

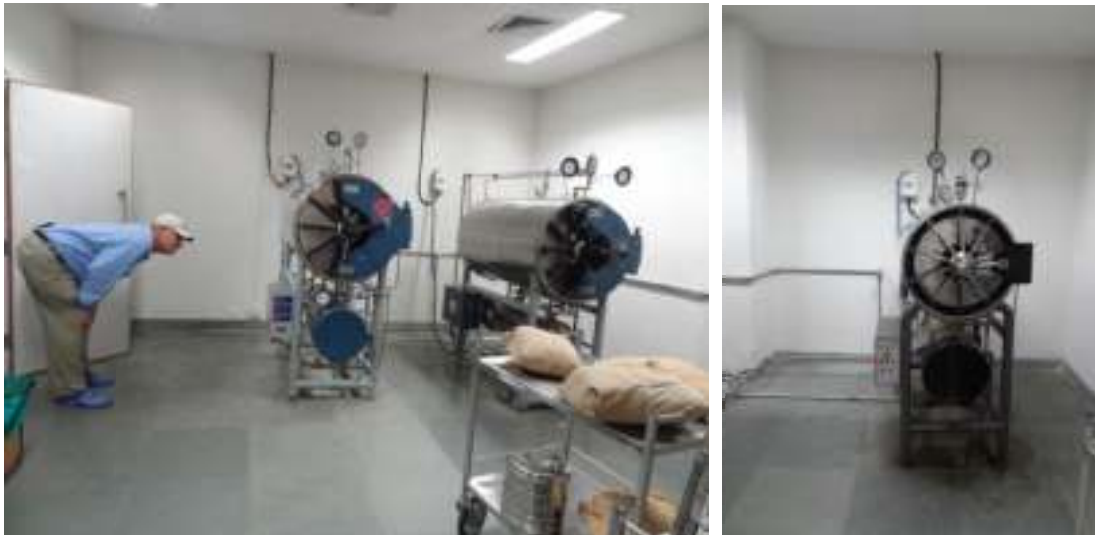
Figure 39. Inspecting unanchored sterilizers in the Central Sterilization and Supply Department (CSSD)

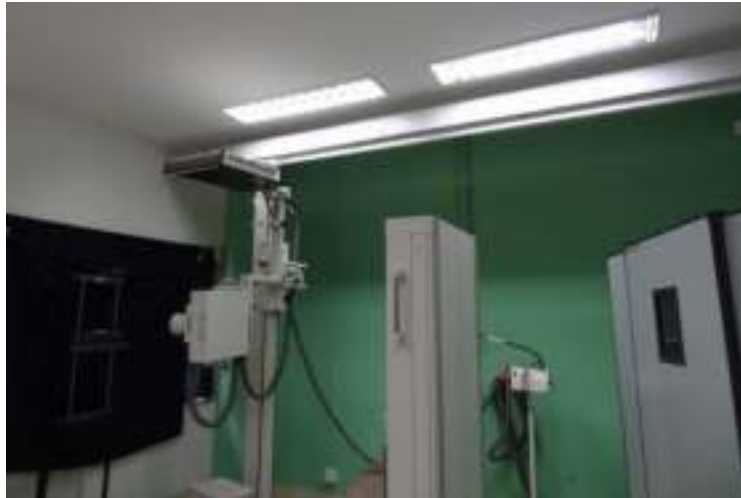
Figure 40. X-ray equipment supported by beam resting on seismically unstable brick partitions

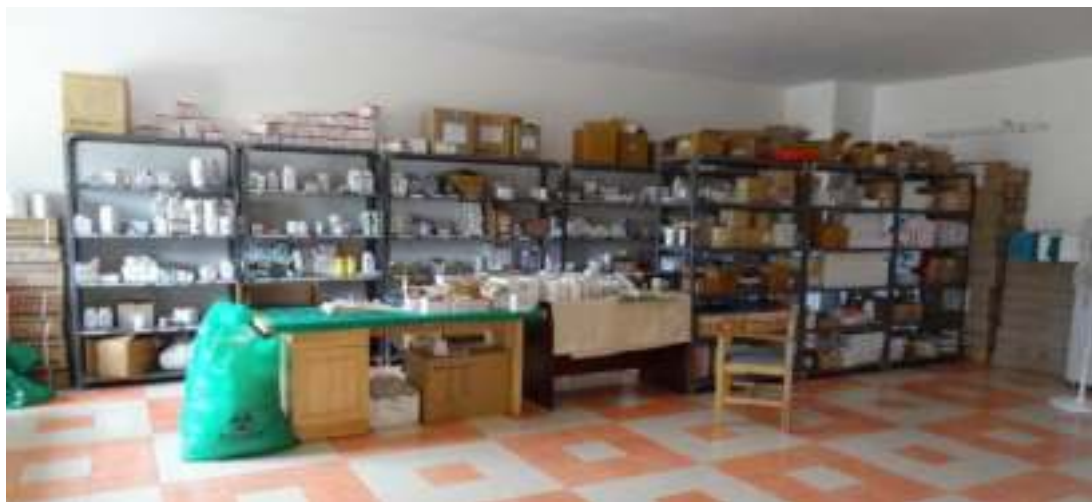
Figure 41. Unanchored racks with unrestrained medicines in inpatient pharmacy, top level of Service Block

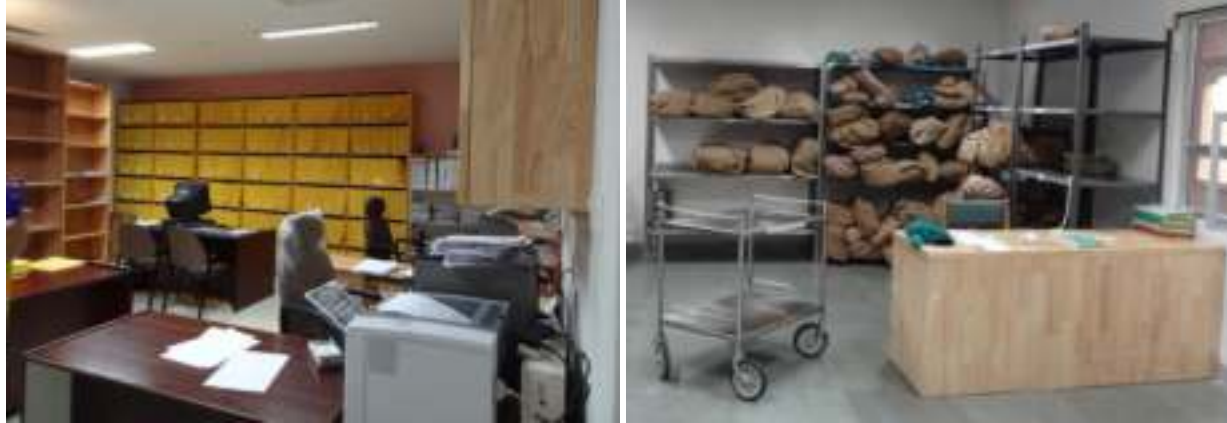
Figure 42. Large, unanchored medical records shelving (left) and unsecured racks in CSSD (right) near staff workstations

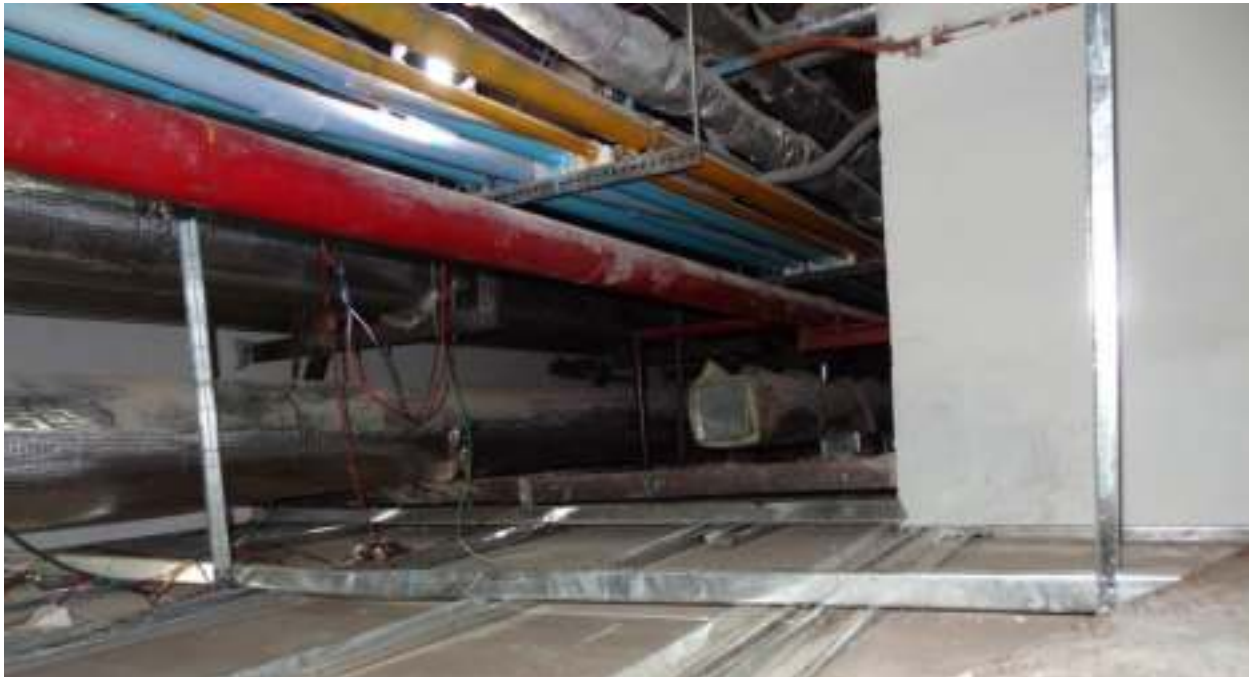
Figure 44. View above suspended ceiling showing support system and utility services. There is no lateral bracing for the suspended ceiling, fire and domestic water pipes, medical gas lines and steam pipes.
