Initial Seismic Vulnerability Assessment of Jigme Dorji Wangchuck National Referral Hospital Thimphu, Bhutan

July 31, 2012

Prepared for the World Health Organization Regional Office for South-East Asia by

GEOHAZARDS

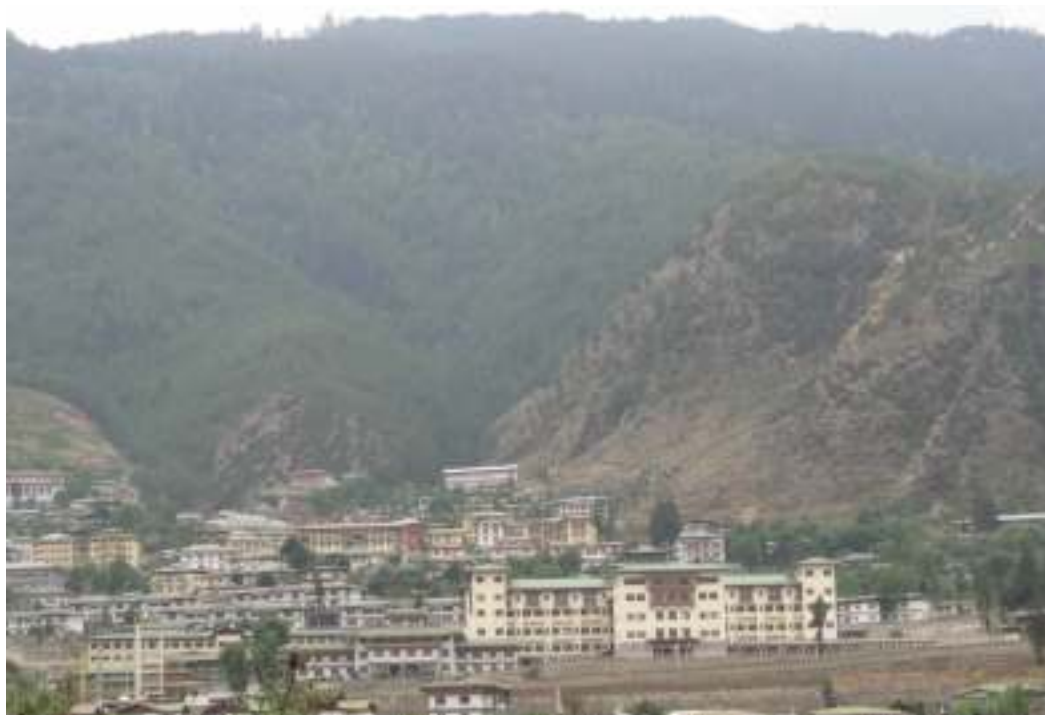
Figure 3. Topography near the hospital (pale yellow building in foreground); note large retaining wall in front of hospital

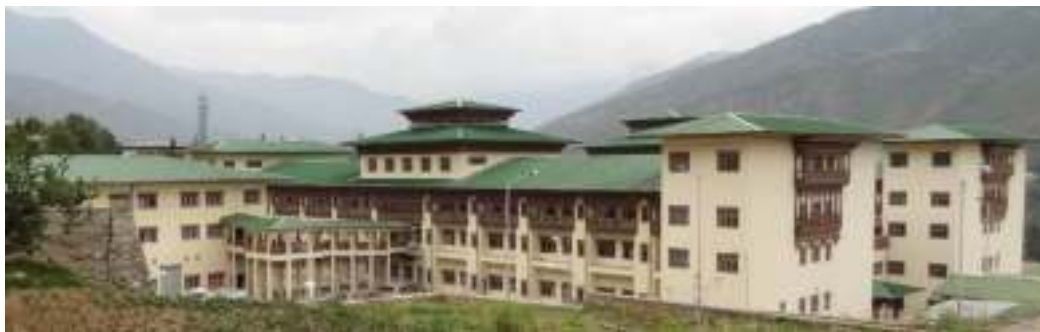
Figure 6. Rear view of Main Hospital building showing location of Service Block (at left) and connecting bridge (center)

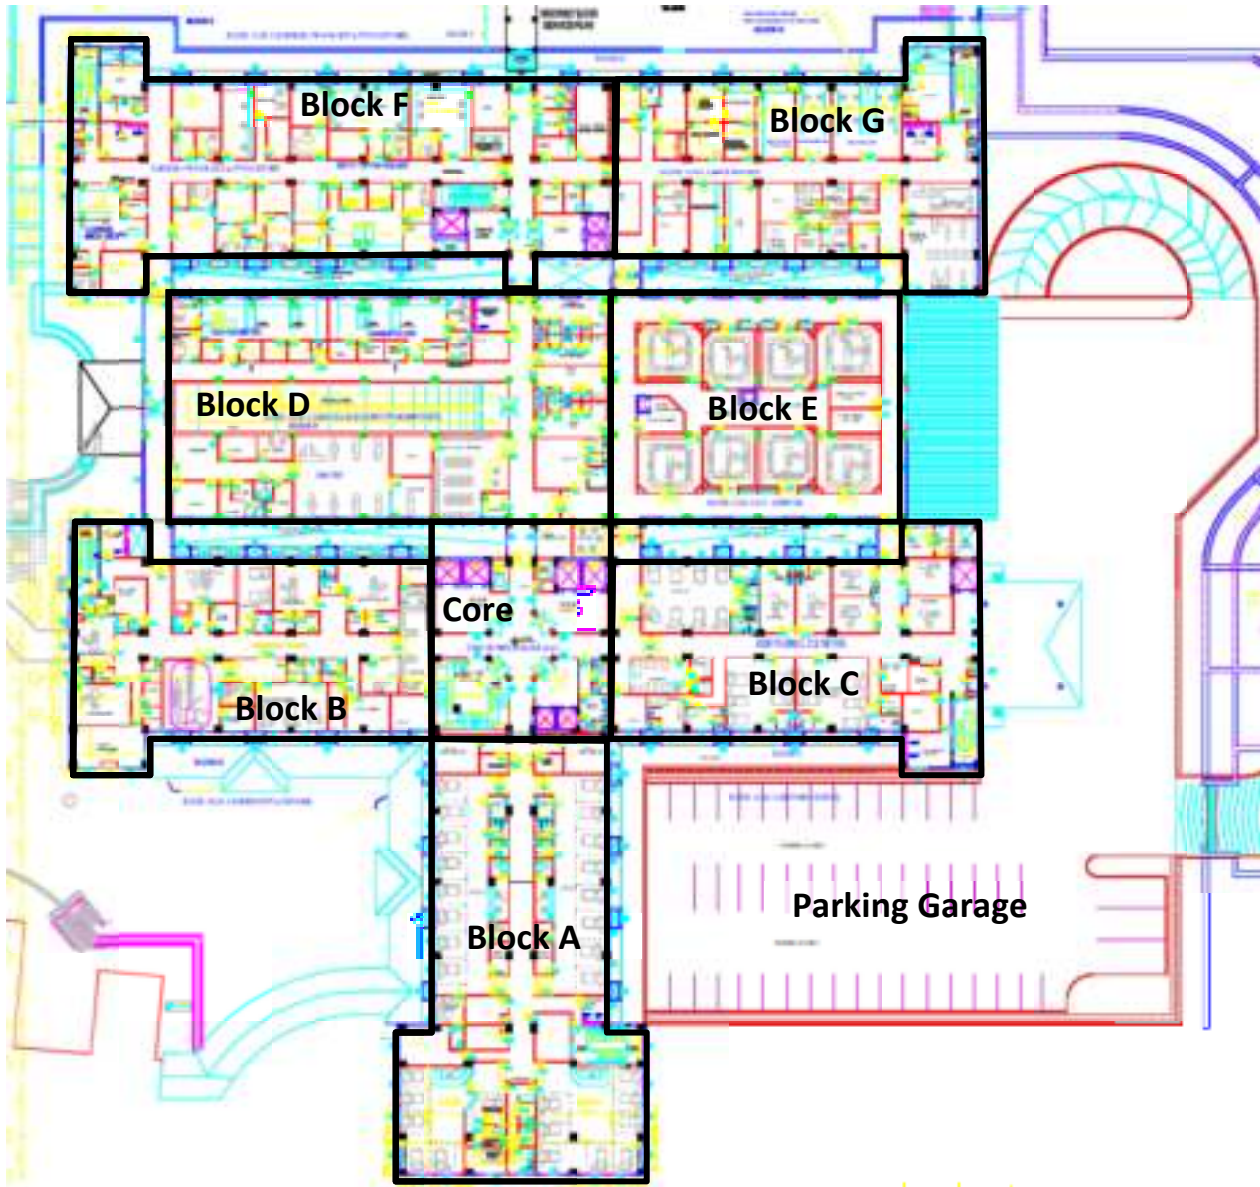
While the building appears highly irregular in plan, it consists of eight relatively regularly shaped blocks (Blocks A-G, plus a core) separated by seismic joints, as Figure 7 (following page) shows. Per the Indian Standards, these joints should be 100mm. The building has a steel roof truss covered by corrugated metal roofing. At the roof levels, there are concrete beams in both directions below the roof trusses, but no concrete slabs that would act as a diaphragm (a horizontal structural member that distributes earthquake forces to the building's frames and/or walls).

Figure 7. Plan of main hospital building showing Blocks A-G

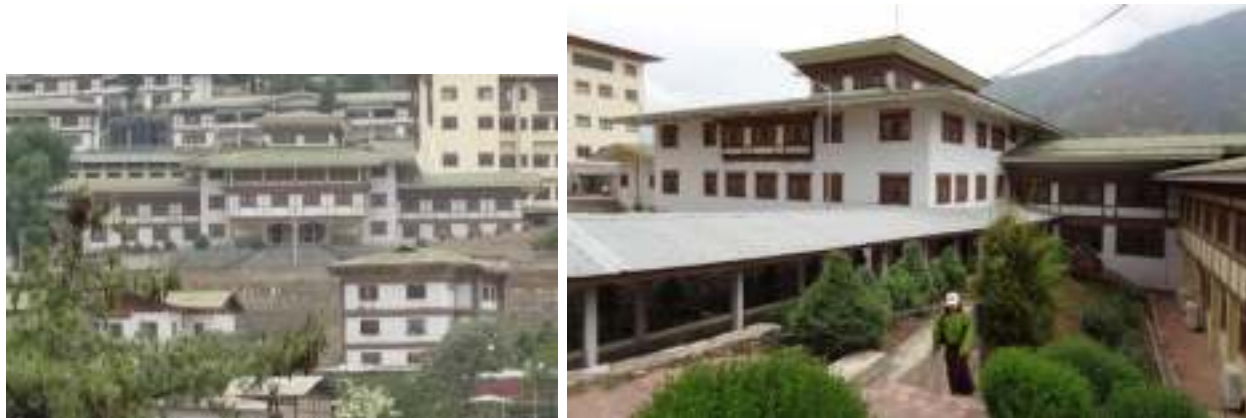
Figure 10. Front view (left) showing columns supporting overhang; and rear view (right) of Filter Clinic building

The evaluation team presumed that the building was designed to meet the prior version of Indian Standards IS 1893 (for earthquake-resistant design) and IS 13920 (for ductile detailing of reinforced concrete). Neither structural nor architectural drawings were available. The columns supporting the bays overhanging the entrance are potentially vulnerable, because the lack of masonry infill makes the columns more flexible and may encourage damage to concentrate there. The columns also have decorative *Zhu* at the top, which will likely confine the top of the column and force damage to occur lower in the column than the design engineer intended, in a section that is not adequately reinforced.

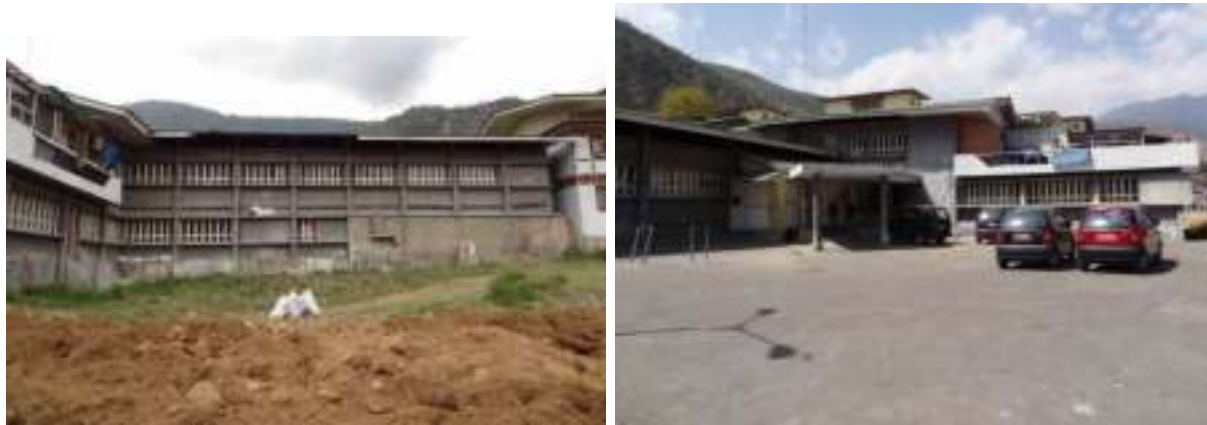
The oldest portions of the hospital's medical buildings include the hospital's old main building, which may have been completed as early as 1972, plus additions that may have been built in the 1980s. The building houses the pediatric OPD, pediatric physiotherapy, rehydration unit, forensic department, public health laboratory, plus the hospital conference hall, canteen, and library and an office for the newly formed UMSB. No structural or architectural drawings are available for the building or additions. The oldest portions, painted dark gray at the time of this report and shown in Figure 11 (following page), appear to be concrete frames built without ductile detailing. The building has captive columns, which are prone to major damage and collapse.

Figure 11. Front and side views of old part of Filter Clinic building (Old Building)

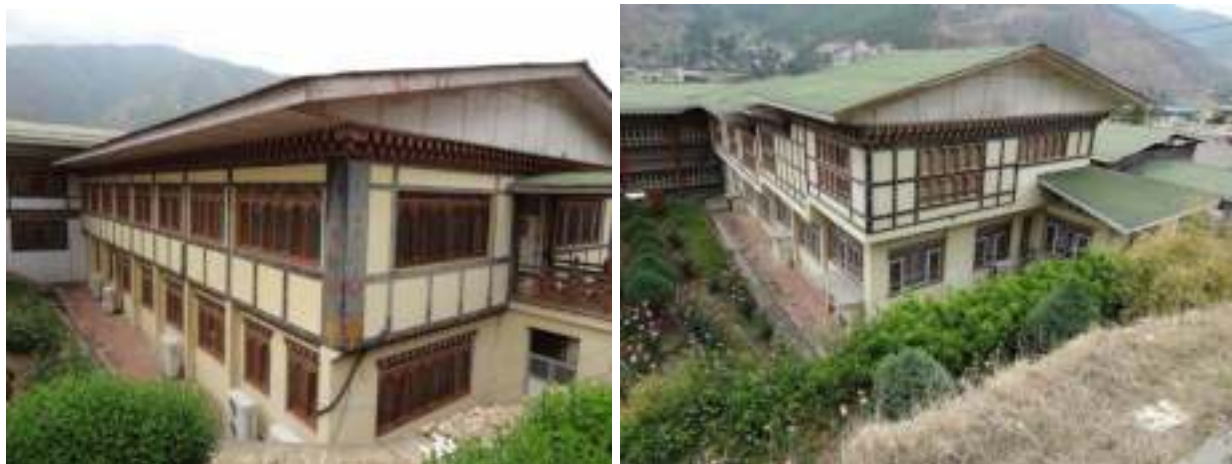
Figure 12 (following page) shows the two wings added to the rear of the building over time, likely beginning as early as the late 1970s. The wing closest to the main hospital (left photo) is a reinforced concrete frame building with masonry infill walls. The second wing appears to be mixed construction built over time, with a reinforced concrete frame in the ground storey and a timber upper storey, and a single-storey, irregular-in-plan unreinforced masonry wrap-around addition on the back and side.

Figure 12. Rear exterior views of old part of filter clinic building, showing additions

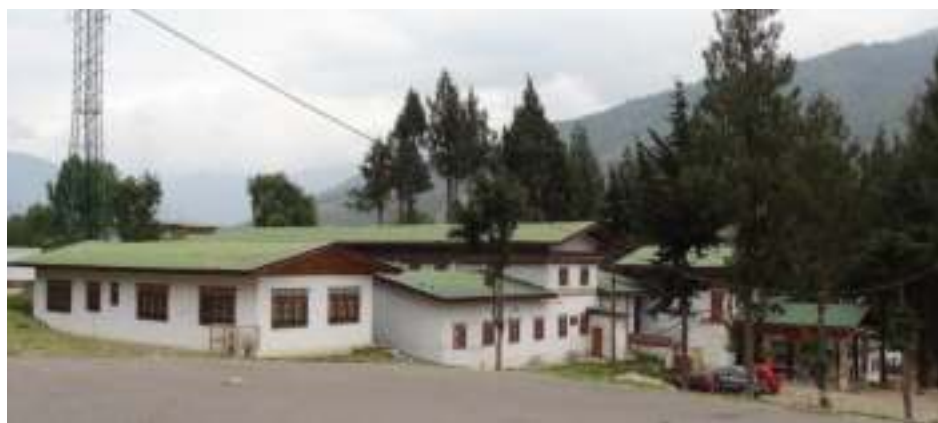
The main community health buildings are interconnected ground plus one storey reinforced concrete frame buildings with unreinforced brick or block infill walls, as shown in Figure 13 below. The frames appear to be complete frames (meaning they all have beams and columns), but as Figure 14 (following page) shows, the building has a very irregular and complex configuration, especially on the entrance side facing the main hospital. Short columns exist in some locations. The buildings were likely built prior to India’s adoption of a modern ductile detailing code in 1993, which would mean they lack earthquake-resistant ductile details and are thus more vulnerable to earthquake damage. A more recently constructed L-shaped building (which does not appear on a 2002 site plan) on the west side of the main complex (far left of Figure 13) appears to be unreinforced masonry.

Figure 13. Overall view of main complex of community health buildings

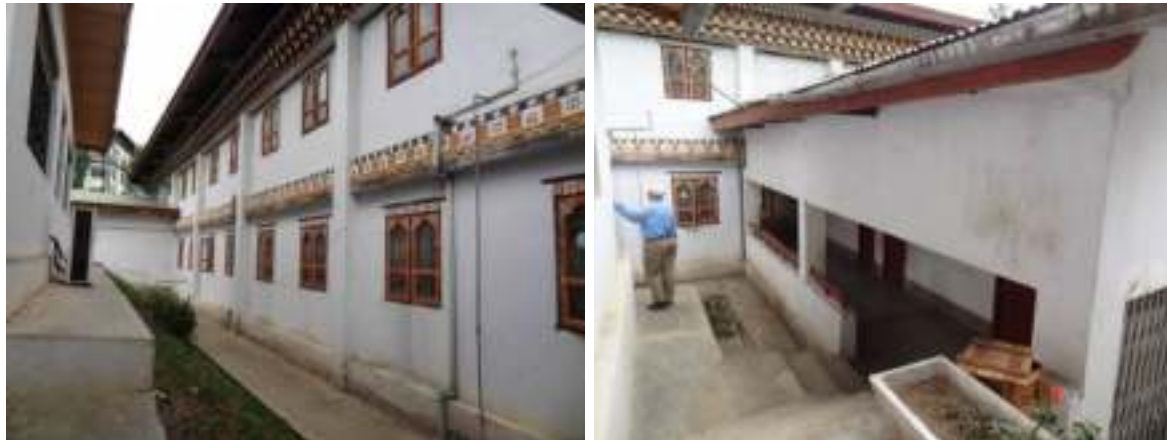
Figure 14. Views of back side of main community health buildings showing complex configuration

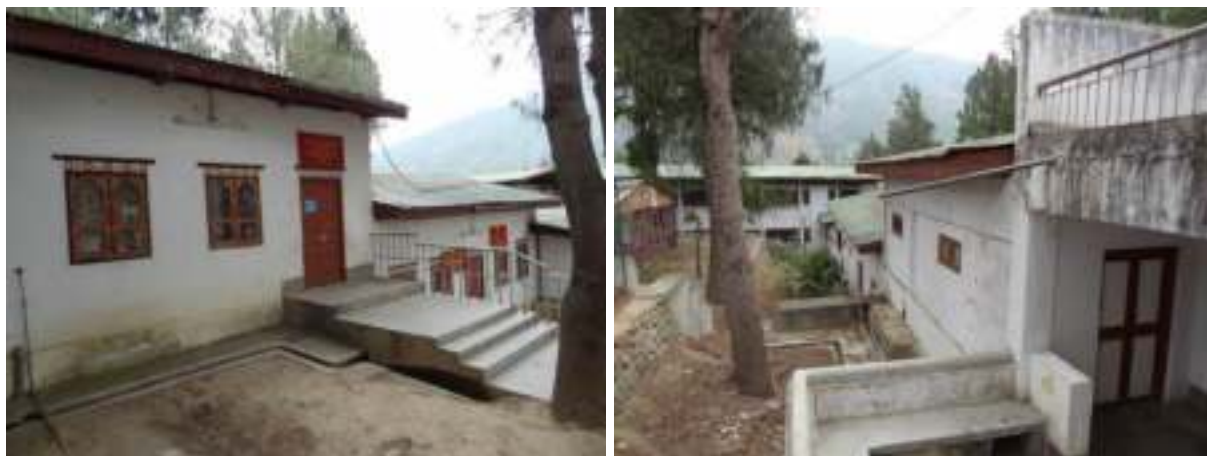
The Hand Therapy and Splinting Clinic, part of Physiotherapy, occupies the upper of two buildings that appear to be unreinforced masonry construction and that step down the slope below the main community health buildings, as Figure 15 shows. The lower of the two buildings houses the Tuberculosis Unit and the Voluntary Counseling and Testing Unit.

Figure 15. Front (left) and rear (right) views of Hand Therapy Clinic and TB Unit and Voluntary Testing Unit Building

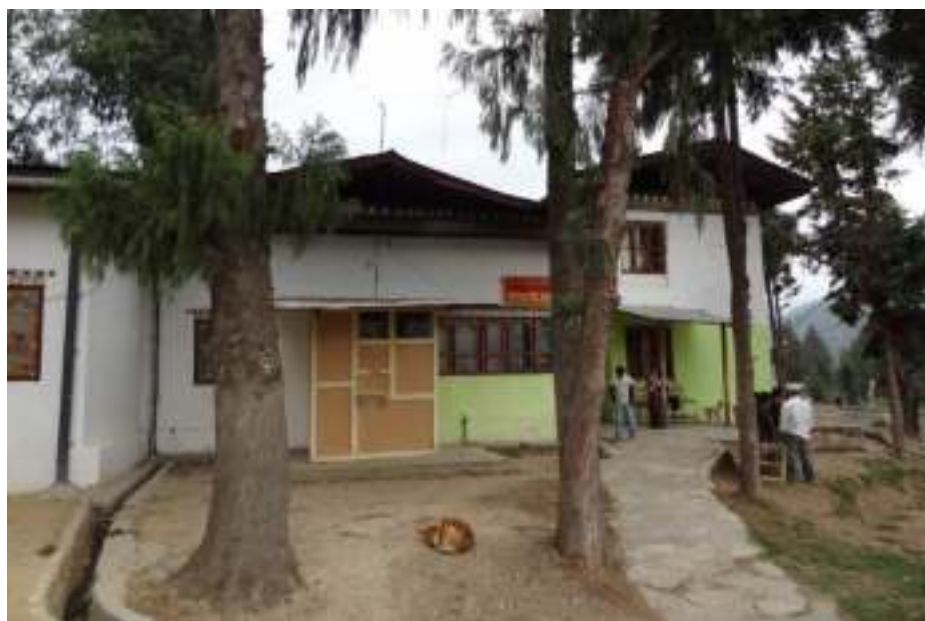
The Psychiatric Ward consists of two buildings shown in Figure 16 (following page): a single storey building in front that appears to be unreinforced masonry, and a ground plus one storey reinforced concrete frame building with either unreinforced brick or concrete block infill walls. The buildings are at the downhill end of the group of community health buildings, immediately down of and adjacent to the Health Help Center. The reinforced concrete frame building, the side of which can be seen in the right-hand photo in Figure 15, has captive columns created by partial height infill walls below the windows. The reinforced concrete frame building may have been built at about the same time as the old pediatric

Figure 16. Psychiatric ward buildings

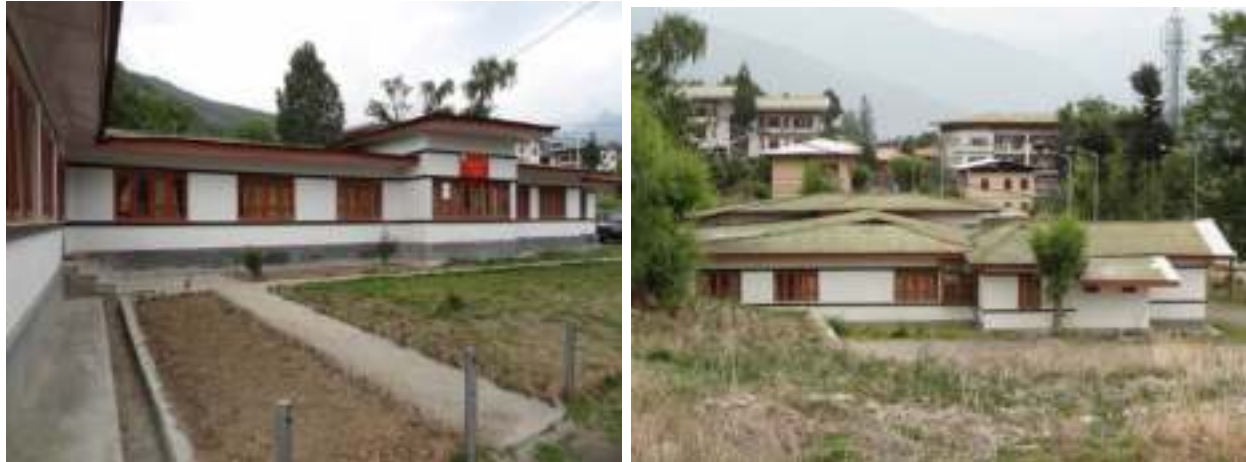
The Health Infrastructure Development Division is responsible for designing health facilities throughout Bhutan. Following a damaging earthquake, HIDD structural engineers will need to make safety and damage assessments of the hospital buildings and other health facilities. The HIDD office building, shown in Figure 18 (following page), appears to be unreinforced masonry, probably brick. The configuration is approximately an “L” shape, with irregularities in plan. The building has a painted band at the lintel level, but this band is assumed to be an architectural decoration. The evaluation team understands that the building was not built in accordance with Indian Standard IS 4326 and therefore lacks earthquake-resistant features such as seismic bands. The building has single wythe brick partitions that are likely to collapse during strong earthquake shaking.

Figure 18. Front (left) and side (right) views of HIDD office

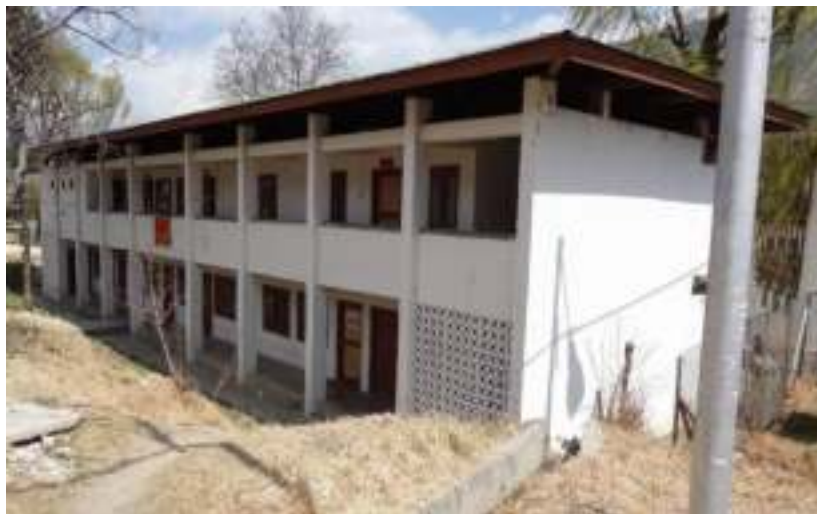
The Maintenance Division's office building, shown in Figure 19, is a ground plus one storey reinforced concrete frame building with unreinforced masonry infill. There are no columns along the window line, only along the corridor. The building has few infill walls in the longitudinal direction, which reduces its strength. The rooms on the ground storey are being used for storage, rather than as offices. The building was apparently built in the 1980s and thus, is assumed not to have ductile detailing.

Figure 19. Maintenance office building

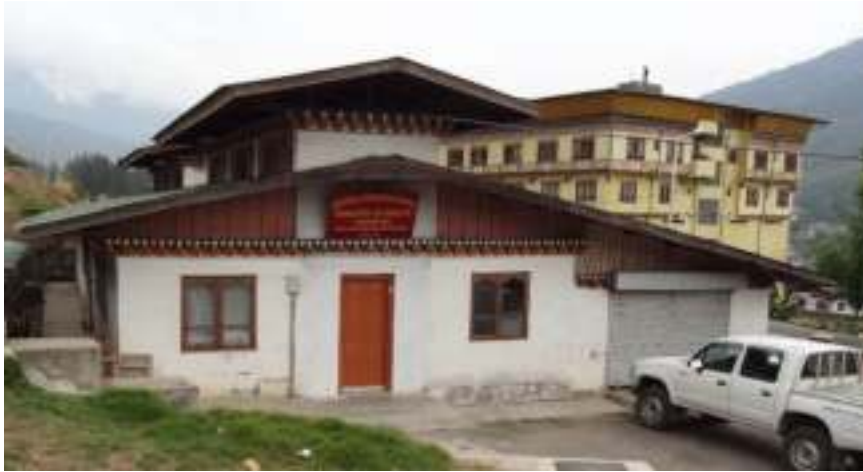
workshop space. The building has clerestory windows with short columns above the central corridor. During the 2011 Sikkim earthquake, the unreinforced masonry panels moved within the reinforced concrete frame, opening up some minor cracks.

Figure 20. BMED office building and workshop

The building is vulnerable to significant damage in an earthquake, due to its age and lack of earthquake-resistant features. The unreinforced brick additions are especially vulnerable to damage. There is a possibility that BMED will move to a new building; the evaluation team recommends that move. The building additions contain storage for spare parts and supplies, as well as workshop space with some machinery and tools. BMED staff should ensure that storage shelves and racks are anchored to walls and that shelf contents are protected with shelf restraints, so that they do not fall and break. BMED will need to be able to access tools, supplies and machinery following an earthquake, or at minimum to retrieve them from the building, so that they can repair earthquake damaged medical equipment.

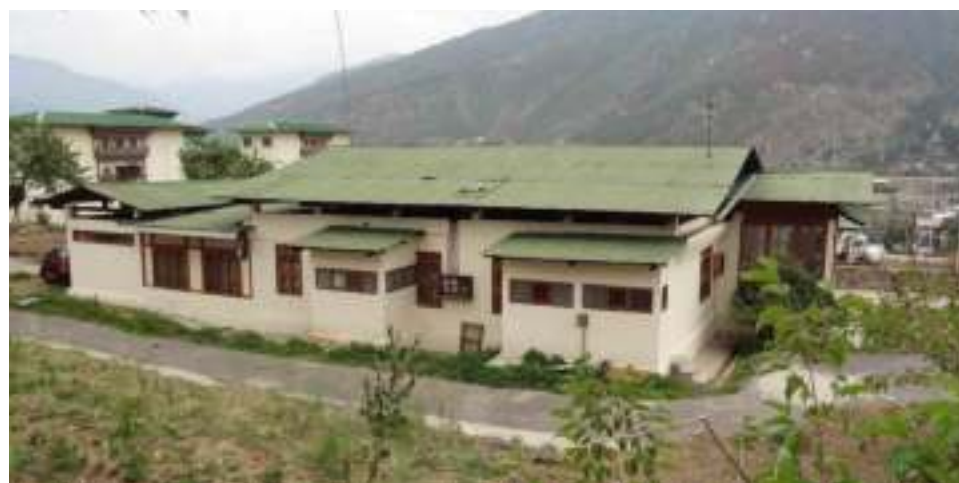
The Medical Superintendent's residence, shown in Figure 21, appears to be built mostly of unreinforced masonry, most likely brick. The building has an irregular configuration in plan, and appears to have been added to over time. The kitchen at the back appears to have once been a separate building; ekra walls and a flat roof have been built to enclose the space between the kitchen and the main house. Toilet blocks are located on the side of the building.

Figure 21. Medical Superintendent's quarters with the main hospital in the background

Because the building has no diaphragm (a horizontal structural member that distributes earthquake forces to the building's frames and/or walls) and no obvious seismic bands, it is highly vulnerable to damage and is likely to collapse in a severe earthquake. The raised roof may lean, during strong earthquake shaking. The brick chimney in the kitchen at the back is likely to collapse even in a moderate earthquake. Given the importance of the MS to continued function of the hospital, the evaluation team strongly recommends that the quarters be seismically retrofitted or replaced as soon as possible.

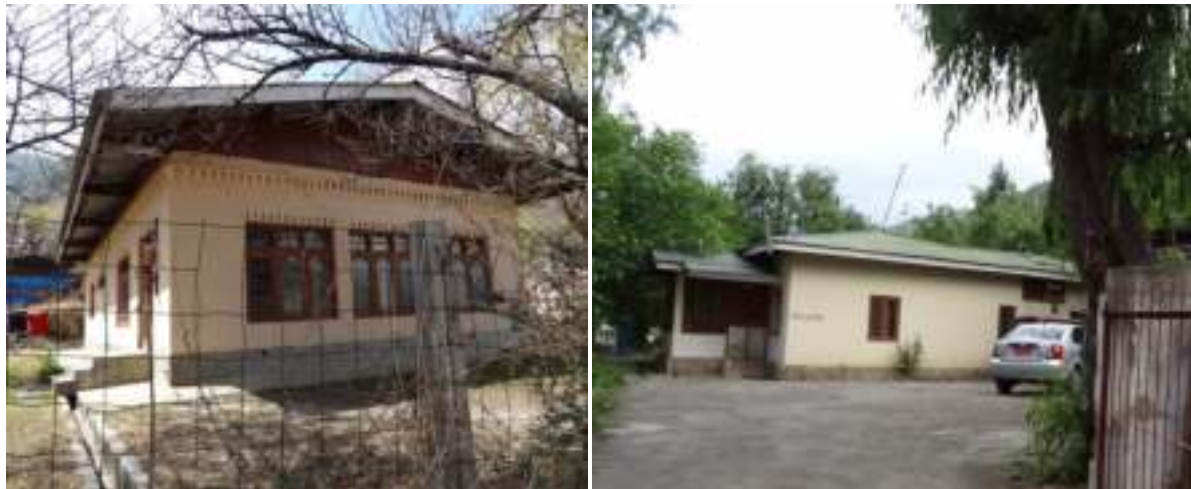
According to a site plan dated 2002, the hospital has eight single family residences, or bungalows, occupied by doctors and senior staff, in addition to the Medical Superintendent's residence. While little information is available for these buildings, they appear to have been constructed of unreinforced masonry, likely brick, sometime in the 1980s. Figure 22 shows two of these bungalows. The building on the left has very little wall across the front, making it relatively weaker. It also has a traditional raised roof, which may tilt or fall in an earthquake.

Figure 22. Two examples of single-family residences (bungalows) for doctors

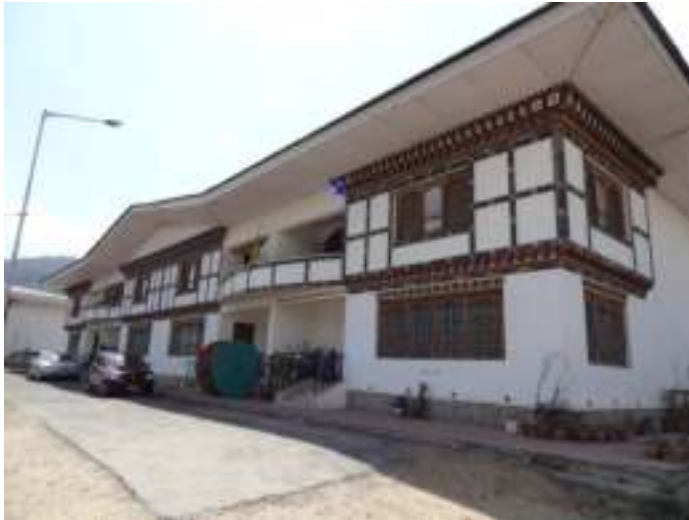
The hospital also has five doctors' fourplexes, shown in Figure 23 (following page), which are reinforced concrete buildings with brick masonry infill walls. These buildings were constructed in 1999. The evaluation team assumed that these buildings were designed to the Indian Standard in effect at the time, which means they would have incorporated some seismic design.

Figure 23. Doctors' fourplex residences

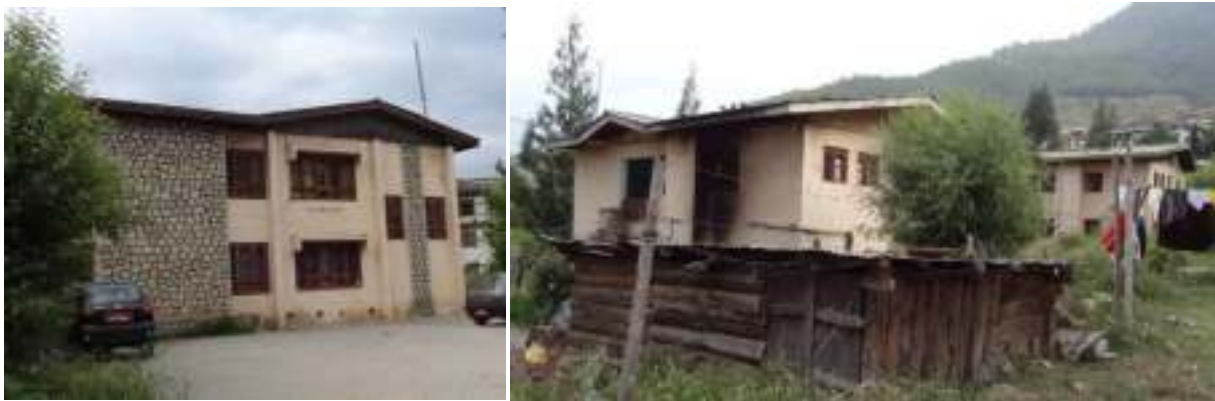
The duplexes shown in Figure 24, which presumably house doctors or other senior staff, appear to be the same age as the nurses' quarters of similar design discussed below, and were likely built around the same time, the early 1980s. The buildings may be stone masonry with some reinforced concrete elements. There appear to be at least two dwelling units per building.

Figure 24. Multifamily doctors quarters

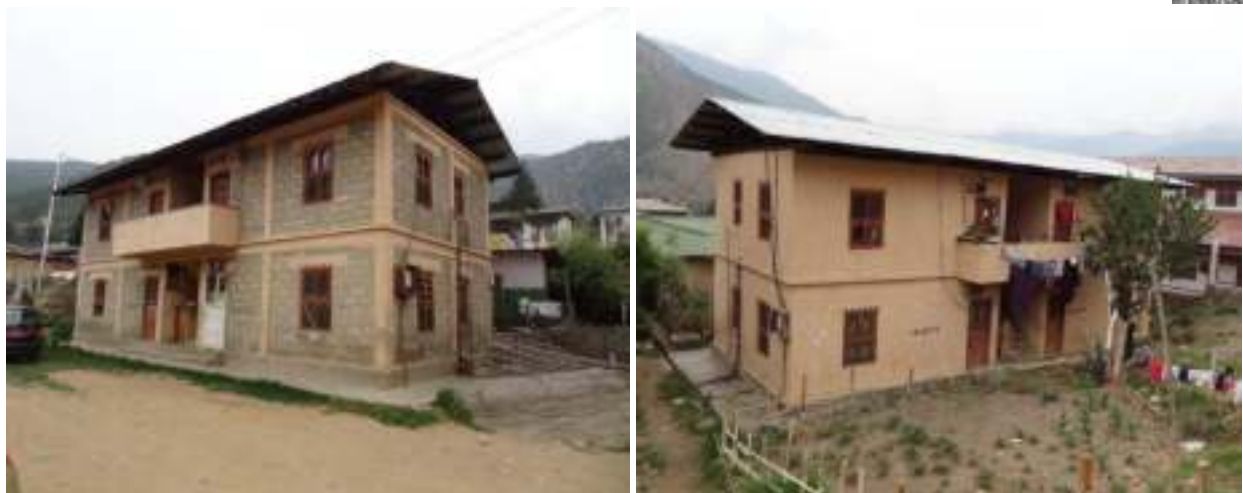
Based on the team's observations, there are four of these buildings. The buildings were constructed in the 1980s. Two are painted and plastered, while two have exposed concrete block; Figure 25 (following page) shows an example of each type. There is a possibility that the painted and plastered buildings have a different wall material, but this is considered unlikely, since the buildings are otherwise identical. The buildings appear to have reinforced concrete frames, with columns at the building corners and perhaps in other locations. Due to their small size, regular configuration and the presence of columns, these buildings are significantly safer than other staff quarters of similar age.

Figure 25. Nurses quarters (Type 1a) with 4 units built of concrete block with some concrete columns; unplastered (left) and plastered (right)

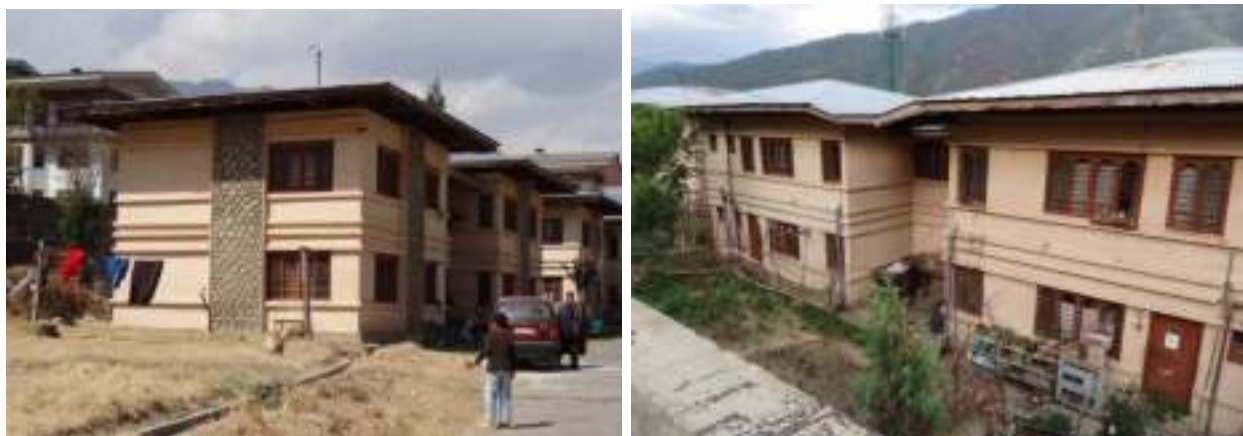
A second type of fourplex unit housing nurses and other staff members, also built in the 1980s, is shown in Figure 26. The evaluation team was told that these buildings were stone masonry, but the team was not able to verify this. As was the case for all the other buildings of this age, there were no drawings available. There are four of these buildings at the site.

Figure 26. Nurses' quarters (Type 1b) with four units

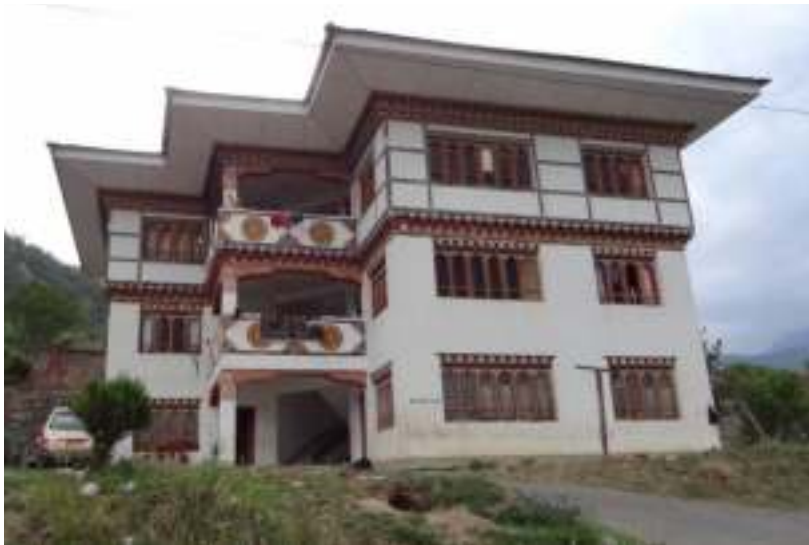
The nurses' quarters shown in Figure 28 are ground plus two storey reinforced concrete with brick masonry infill walls. Architectural drawings are available for these buildings. There are two on the site, each with six units. The buildings were designed in 1998 by the Health Infrastructure Development Project, which has had a policy of following the Indian Standards for a number of years, and were built in 2001. The team assumed that these buildings were designed and built to the 1993 version of IS 13920, the reinforced concrete ductile detailing code.

Figure 28. Newer nurses quarters (Type 3) with 6 units

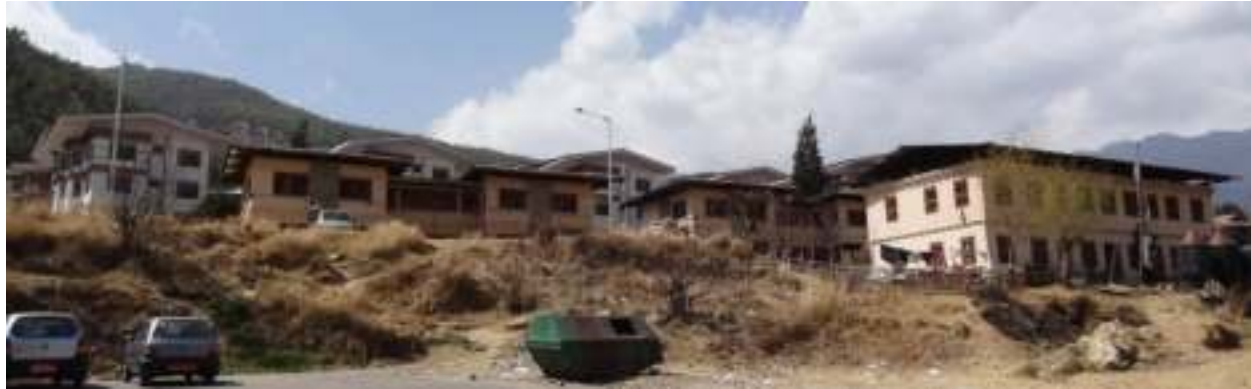
There is a single building of this type on the campus, shown in Figure 29 (following page). The evaluation team was not able to determine the number of units or to learn much about the building. It appears to be built of unreinforced masonry, and may have been built in the 1980s or 1990s.

Figure 29. View of nurses' quarter area showing Type 4 quarters on the far right

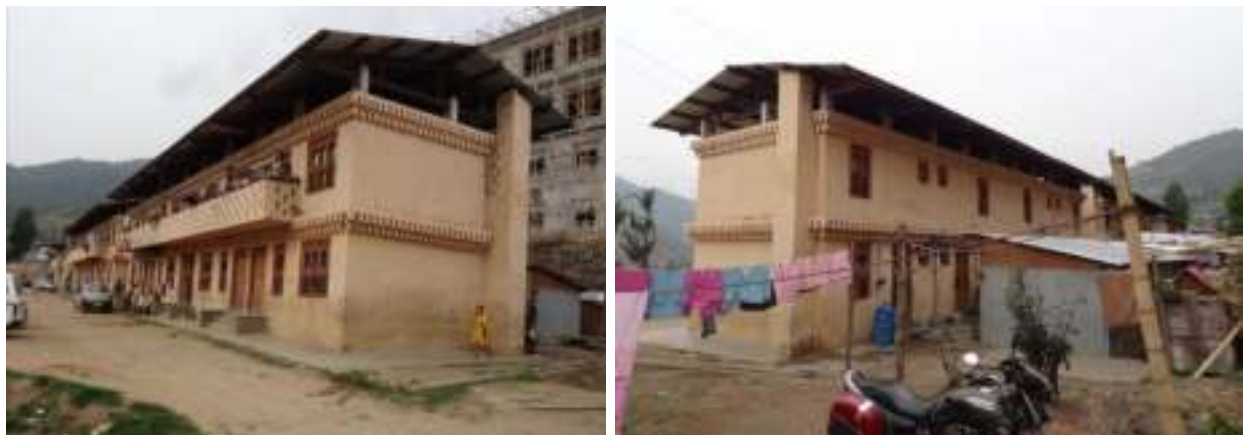
The ambulance drivers' quarters are two eight-unit buildings, likely built in the 1980s. These buildings appear to be constructed of unreinforced masonry with reinforced concrete slabs, balconies and decorative elements. They have apparently non-functional chimneys that may separate from the main building and collapse in an earthquake. If these buildings are unreinforced masonry, then there is little solid wall area in the longitudinal direction, especially on the front side, making the buildings vulnerable to damage.

Figure 30. Front (left) and rear (right) views of ambulance drivers' quarters

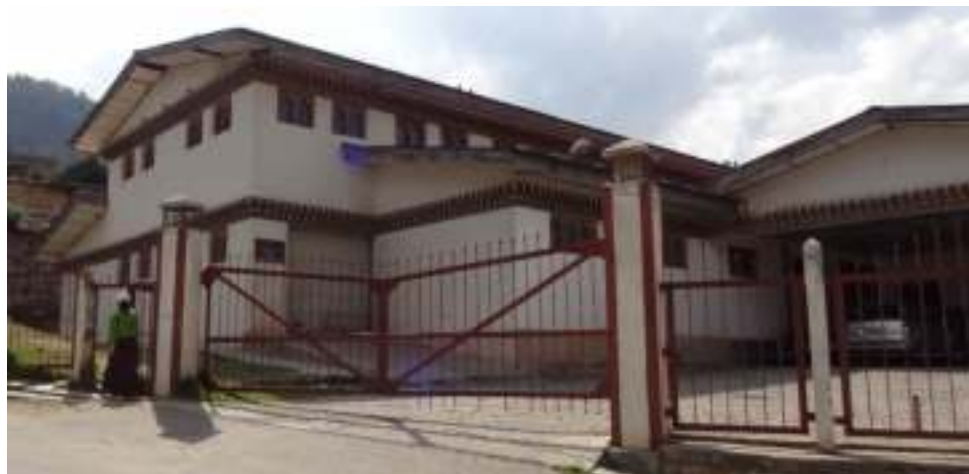
The Central Medical Store, which stores the hospital's supplies, is located on the southeast side of the RIHS. The Central Medical Store is part of a complex belonging to the Drugs, Vaccines and Equipment Division (DVED) of the Ministry of Health. Access is from a separate road that runs behind Chamzangtok Middle Secondary School, less than one kilometer from the hospital. It is difficult to determine if the building housing the Central Medical Store is a reinforced concrete frame building with masonry infill walls, or an unreinforced masonry building. The team observed reinforced concrete beams, but did not observe any reinforced concrete columns. The building has a single tall storey to facilitate the storage of

large volumes of supplies. The tall, relatively slender walls and large open interior spaces make the building much more vulnerable to earthquake damage.

Figure 31. Portion of the DVED building complex housing the Central Medical Store

The building appears to contain unbraced racks and shelves for storing medical supplies. The evaluation team did not have access to the interior of the building and could only view portions of the interior from outside. However, it is likely that supplies will fall to the floor or that racks will overturn in strong earthquake shaking, causing breakage and necessitating a major cleanup and restocking effort. Anchoring the racks to prevent toppling, and providing shelf restraints would prevent the loss of supplies and time-consuming restocking. Table 10 shows the likely performance of the Central Medical Store in the three hypothetical scenario earthquakes that the team considered.

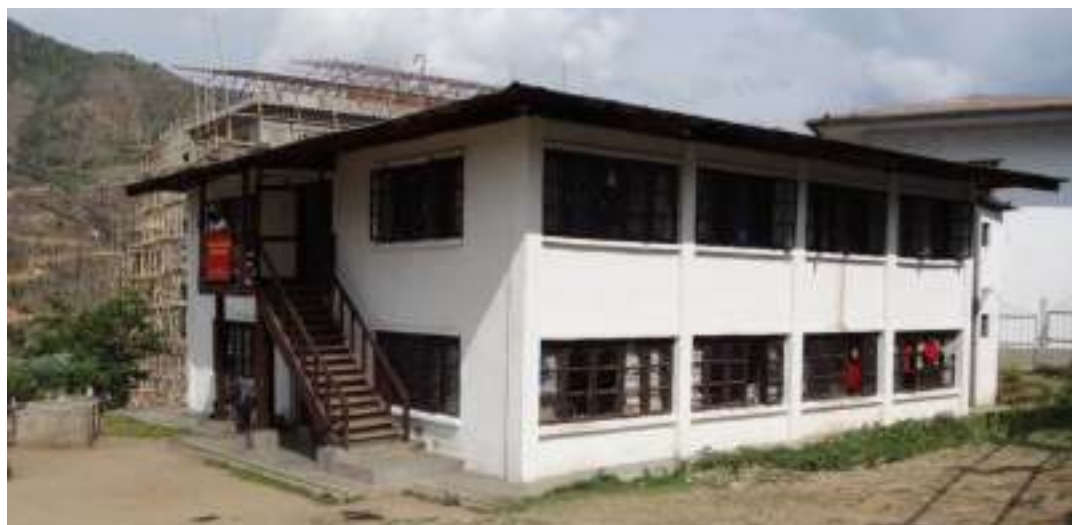
The Patients' Guest House is a ground plus one storey reinforced concrete frame building with assumed unreinforced masonry infill walls of an undetermined type. The guesthouse was established in 2008 with support from Her Royal Highness Ashi Kesang Wangmo Wangchuk, though the team understands that the building was originally built in 1992. The Guest House provides free lodging for economically disadvantaged patients who are receiving ongoing care at the hospital, as well as their families. As

shown in Figure 32, the building has partial height masonry infill walls that create captive columns on parallel sides of the building, a significant earthquake vulnerability. There is an irregularly shaped toilet block (possibly an addition) at the rear of the building.

Figure 32. Patients’ Guest House

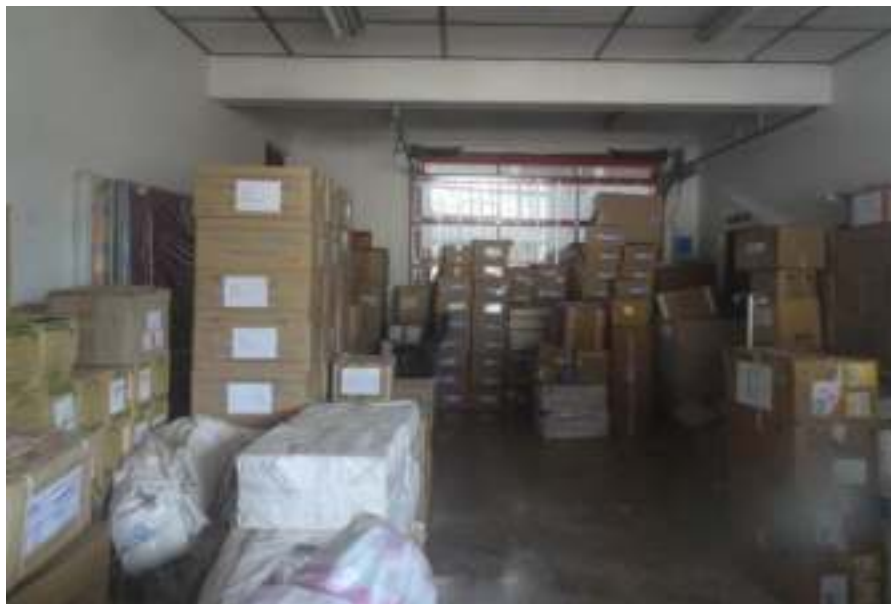
Figure 42 (following page) shows two areas with desks and work stations located near heavy shelves that could topple and injure staff members during an earthquake. In the Central Medical Store, items are also in tall, narrow stacks resting on the floor, as Figure 43 (following page) shows. In all of these locations, unrestrained items will fall, become disorganized or ruined, and require time-consuming cleanup or restocking. Simple hardware to anchor shelving to walls or floor, combined with shelf restraint systems, can prevent this from happening.

Figure 43. Supplies stacked in Central Medical Store

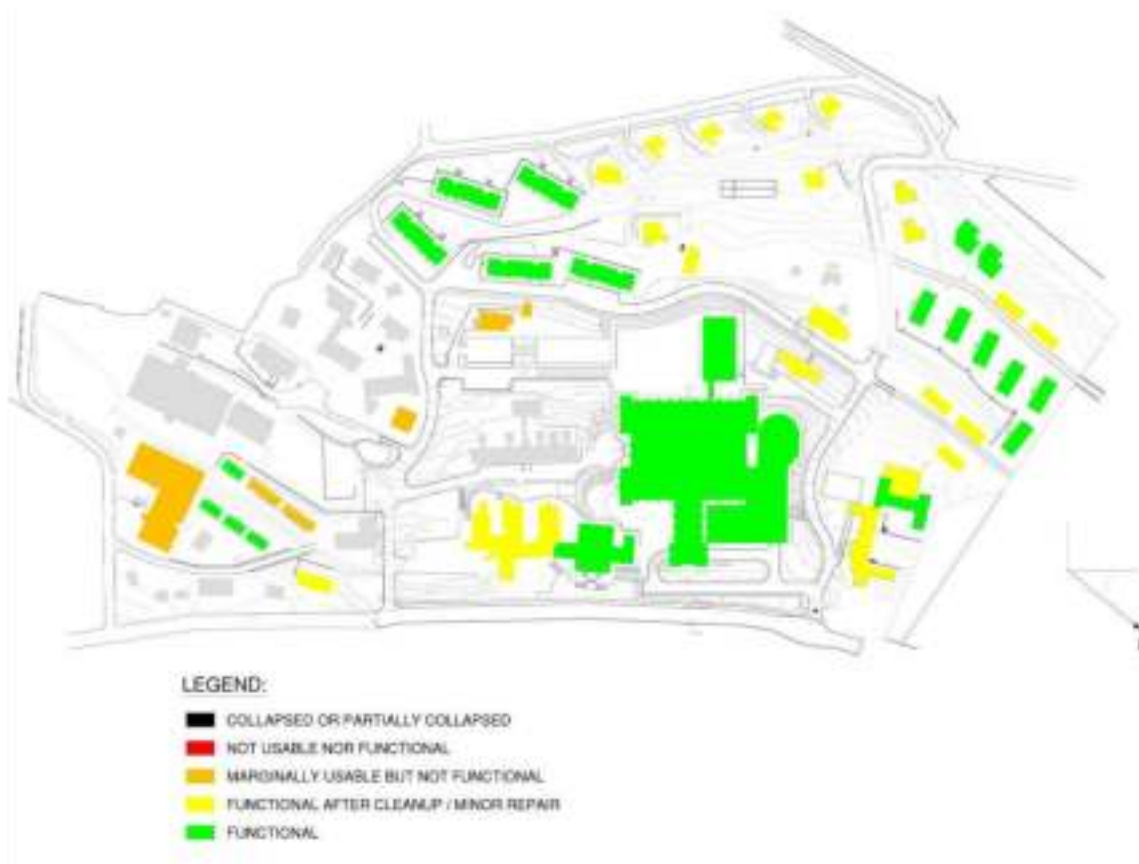
Figure 46 (following page) shows the anticipated performance of the hospital’s buildings, in terms of functionality. The actual state of functionality is highly uncertain, due to uncertainty in the exact nature of ground shaking and in the team’s existing knowledge of structural and nonstructural systems. Each building could be one performance level higher or lower than shown. One performance level is shown for illustrative purposes. Short term interruptions of services that do not require evacuations are not considered.

Figure 46. Site plan showing performance of hospital buildings in M6.1 hypothetical scenario earthquake

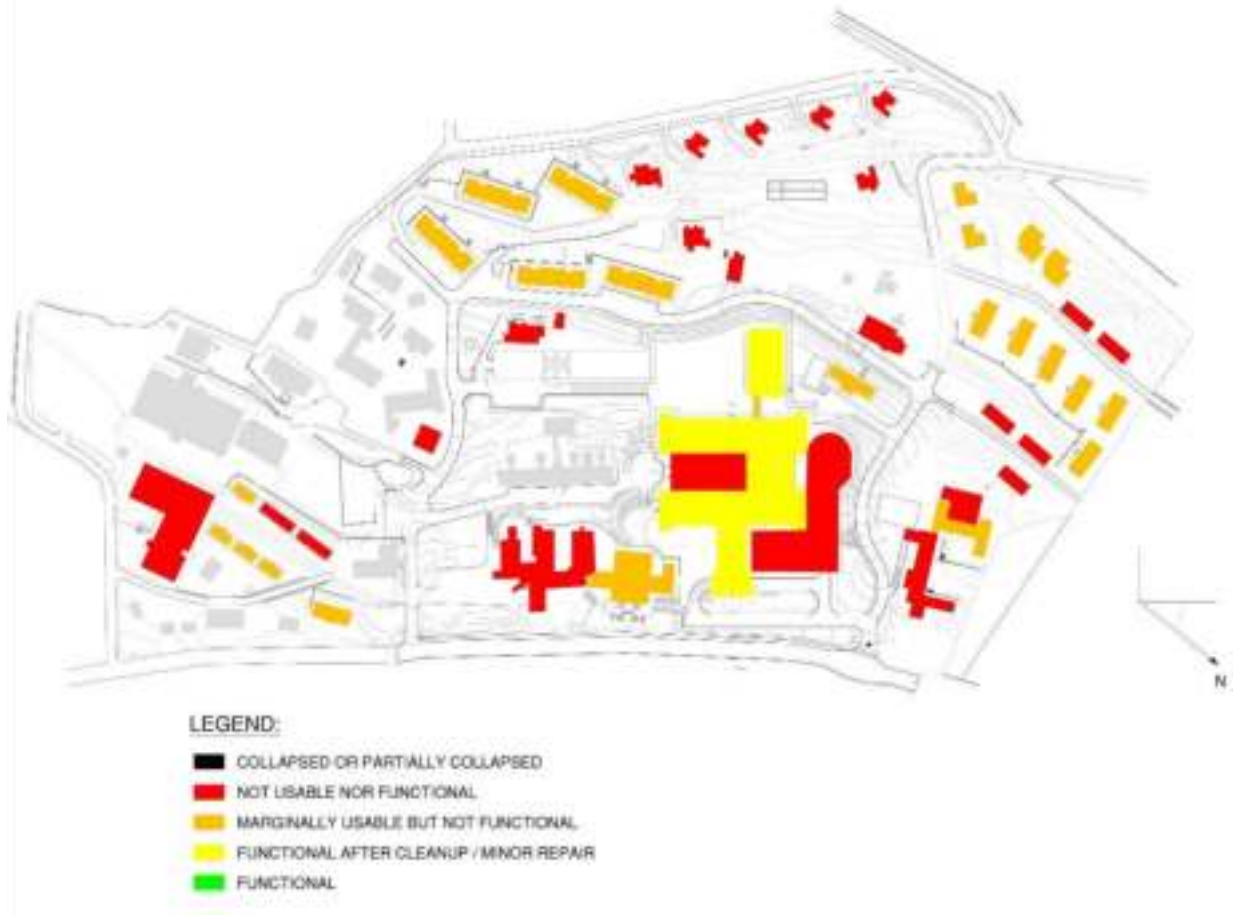
Figure 48 (following page) shows the anticipated performance of the hospital’s buildings, in terms of functionality. The actual state of functionality is highly uncertain, due to uncertainty in the exact nature of ground shaking and in the team’s existing knowledge of structural and nonstructural systems. Each building could be one performance level higher or lower than shown. One performance level is shown for illustrative purposes. Short-term interruptions of services that do not require evacuations are not considered. Most areas of the main hospital building would be functional after some cleanup, but the lack of medical gas limits certain essential functions. Damage to the ramp block and lifts impedes the movement of patients between floors. Some staff quarters, the central medical store, the old and the community health buildings are all heavily damaged and may be unsafe to use. The hospital is able to deliver some essential care for a limited time period, until the generator fuel and water supply run out.

Figure 48. Likely performance of hospital buildings in M7 hypothetical scenario earthquake

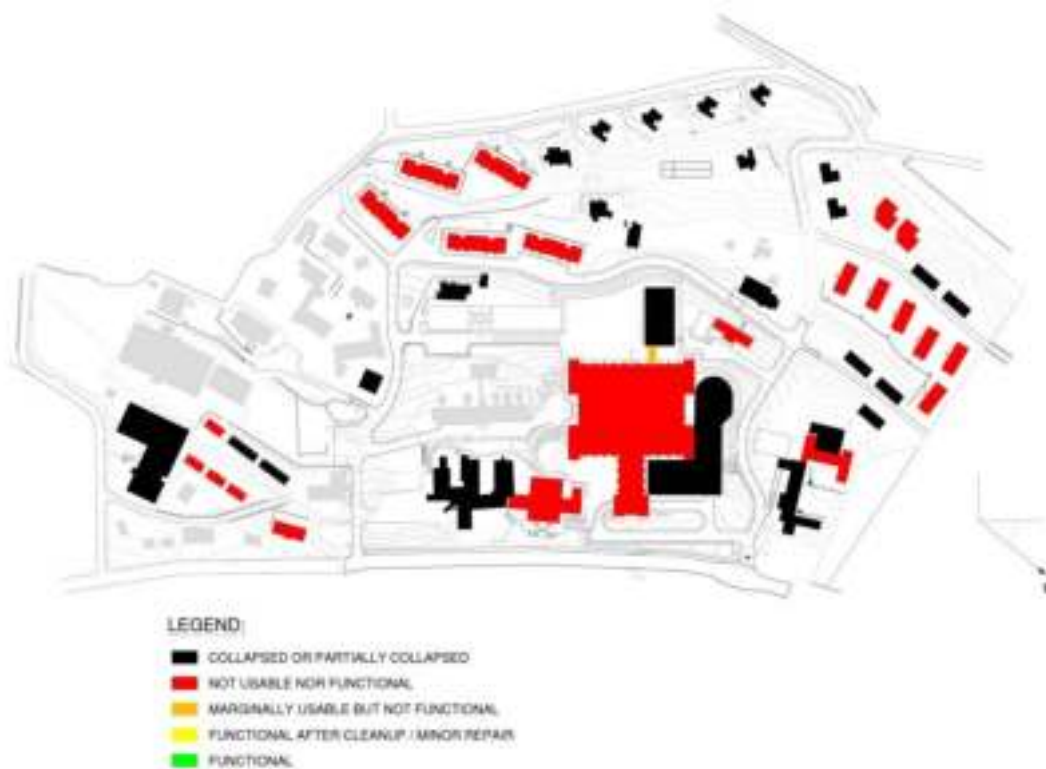
Figure 50 below shows the anticipated performance of the hospital’s buildings, in terms of functionality. The main hospital has not collapsed and has protected the lives of most inside, but a number of other buildings at the site may have collapsed. The hospital is able to provide austere care in the immediate post-earthquake period. The main building may be repairable, but the damage is extensive and full repairs would take months or longer.

Figure 50. Likely performance of hospital buildings in M8.6 hypothetical scenario earthquake
